British European Airways Flight 548

From Wikipedia, the free encyclopedia
(Redirected from Staines air disaster)

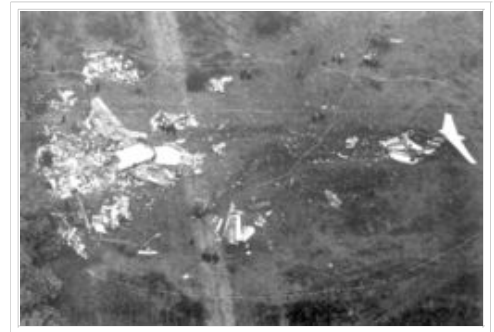
from which there was no possibility of recovery. The aircraft rapidly descended with a high, nose-up attitude, until striking the ground close to the A30 near the King George VI Reservoir on the outskirts of Staines. There was no fire on impact.

The wreckage of *G-ARPI*
