Tenerife disaster

The **Tenerife disaster** took place on March 27, 1977, at 17:06:56 local time (also GMT), when two Boeing 747 airliners collided at Tenerife North Airport on the island of Tenerife, Canary Islands, Spain, killing 583 people. The accident still has the highest number of fatalities (excluding ground fatalities) of any single accident in aviation history.

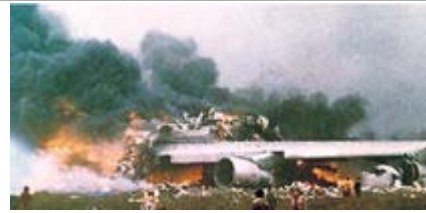
Pan Am 1736 ablaze after its collision with KLM 4805

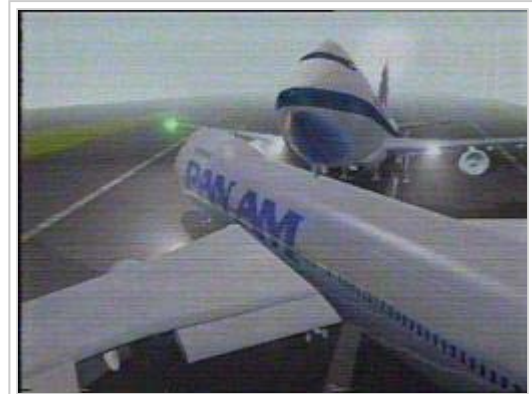
A computer generated image of the impact

According to the CVR, Captain Grubbs, captain of the Pan Am plane, spotted the KLM's landing lights just as the plane approached exit C4. The Pan Am crew applied full power and took a sharp left turn onto the exit to avoid a collision. The KLM plane attempted to avoid a collision by climbing away, scraping the tail of
